# **INDOOR AIR QUALITY ASSESSMENT**

**Salem City Hall  
93 Washington Street  
Salem, MA 01970**

Prepared by:  
Massachusetts Department of Public Health  
Center for Environmental Health  
Bureau of Environmental Health Assessment  
Emergency Response/Indoor Air Quality Program  
February 2005

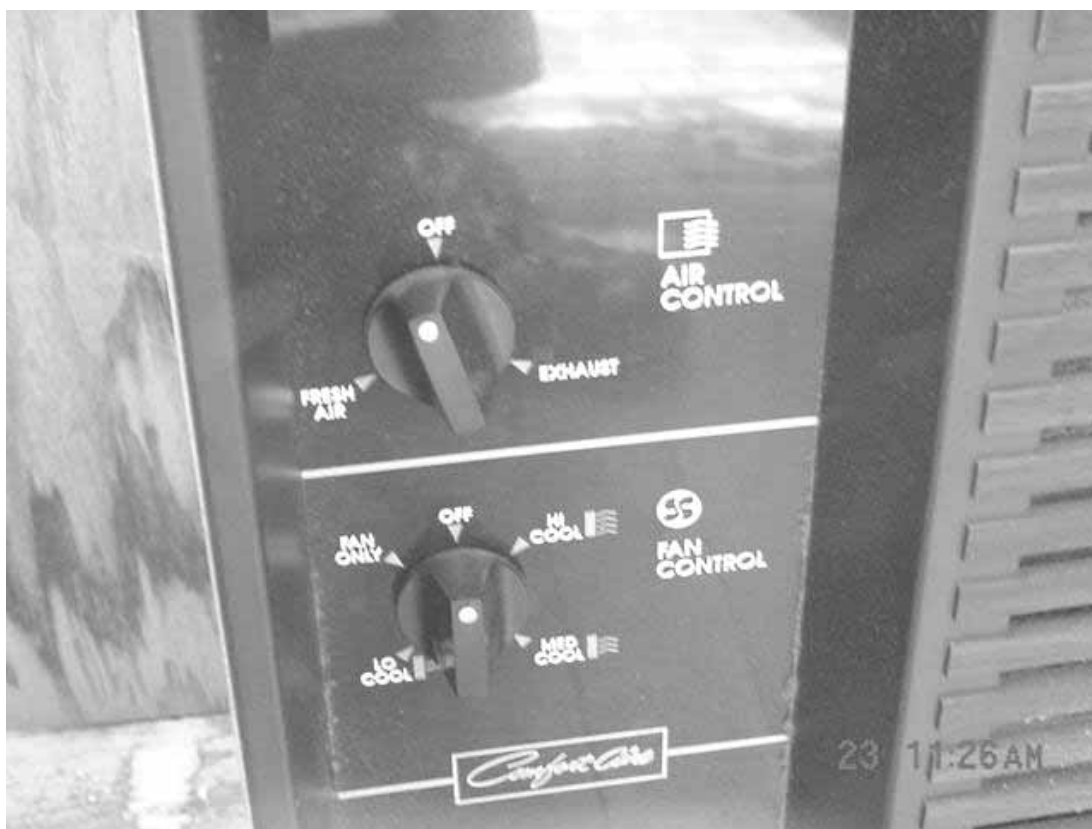
**Picture 1**

Please note, all air conditioners examined were equipped with a “fan only”, “fresh air” and/or an “exhaust open” setting (Picture 1). Operating air conditioning units in such

modes can provide air circulation, since unconditioned outside air is delivered (i.e., air provided by unit equals that of outside temperature).

**Close up of Air Conditioning Control Panel, Note “Fan Only” and “Fresh Air” Controls**

6. Clean/change filters for air-conditioning units as per the manufactures instructions or more frequently if needed. Clean/vacuum interior of units prior to activation to prevent the aerosolization of dirt, dust and particulates.

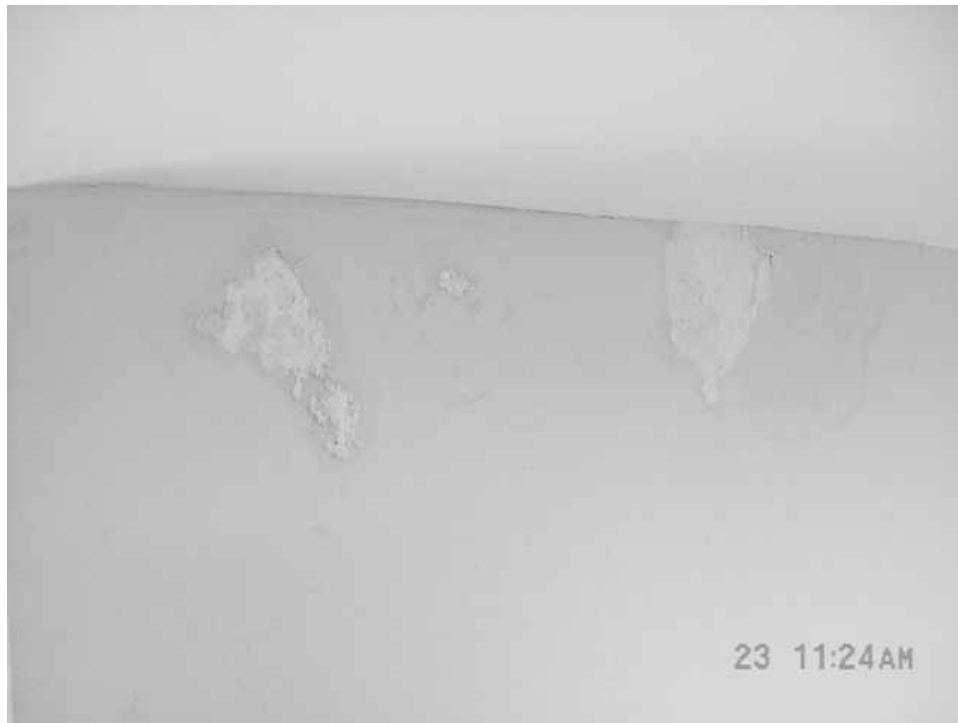
**Picture 2**

Water damaged wall plaster, peeling paint and efflorescence were observed on ceilings and walls in a number of areas in the buildings (Table 1/Pictures 2 and 3). Water damage is most likely the result of water penetration through the building envelope. The majority of water damage was reportedly from historic leaks. Occupants in the Financial Office reported active leaks, primarily at the top corner of the window frame and along the ceiling exterior wall junction, during periods of wind-driven rain (Picture 4).

Efflorescence is a characteristic sign of water damage to brick and mortar, but it is not mold growth. As moisture penetrates and works its way through mortar and brick, water-soluble compounds in mortar and brick dissolve, creating a solution. As the solution moves to the surface of the mortar or brick, the water evaporates, leaving behind white, powdery mineral deposits.

**Efflorescence (i.e., Mineral Deposits) on Attic Office Wall**

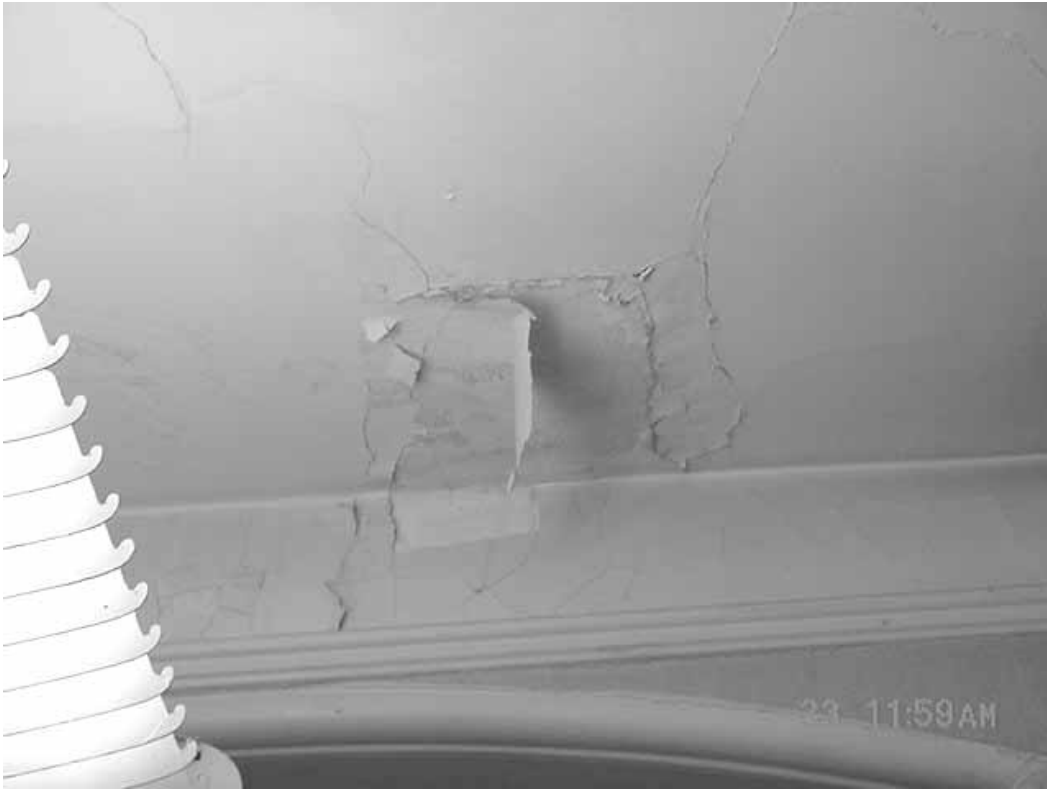
**Picture 3**

**Water Damaged Ceiling Plaster and Peeling Paint**

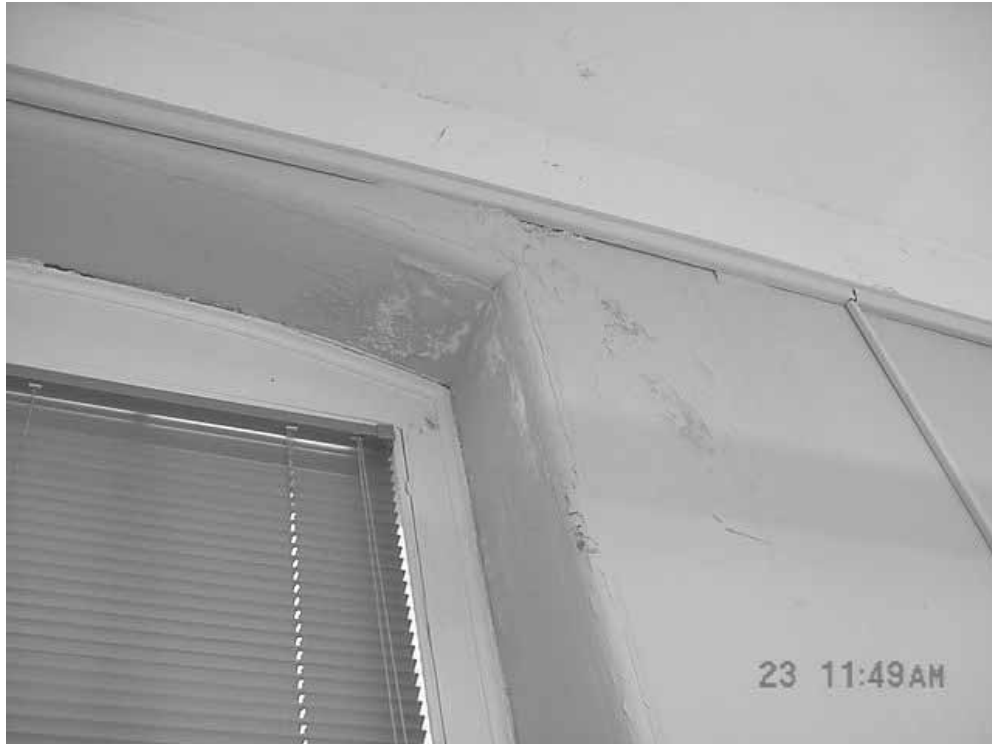
**Picture 4**

**Water Damaged Area of Active Leak Reported in Elections & Registration Office**

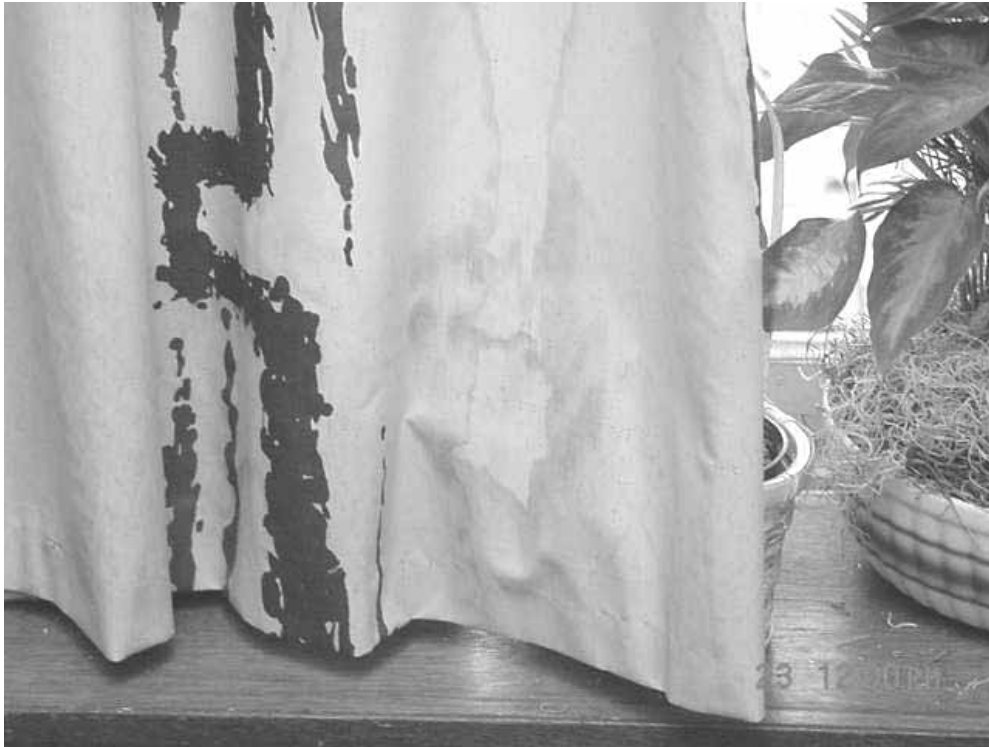
**Picture 5**

Several areas also had water-damaged ceiling tiles and/or curtains (Picture 5). Water-damaged porous materials can provide a medium for mold growth and should be replaced after a moisture source is discovered and repaired.

**Stained/Water Damaged Curtains in First Floor Break Room Collectors Office**

8. Launder and/or vacuum curtains periodically to prevent dust accumulation. Replace stained/water damaged curtains.
9. Seal holes in the floors, walls and ceilings for pipes and cables to prevent the egress of odors and particulates between rooms and floors.

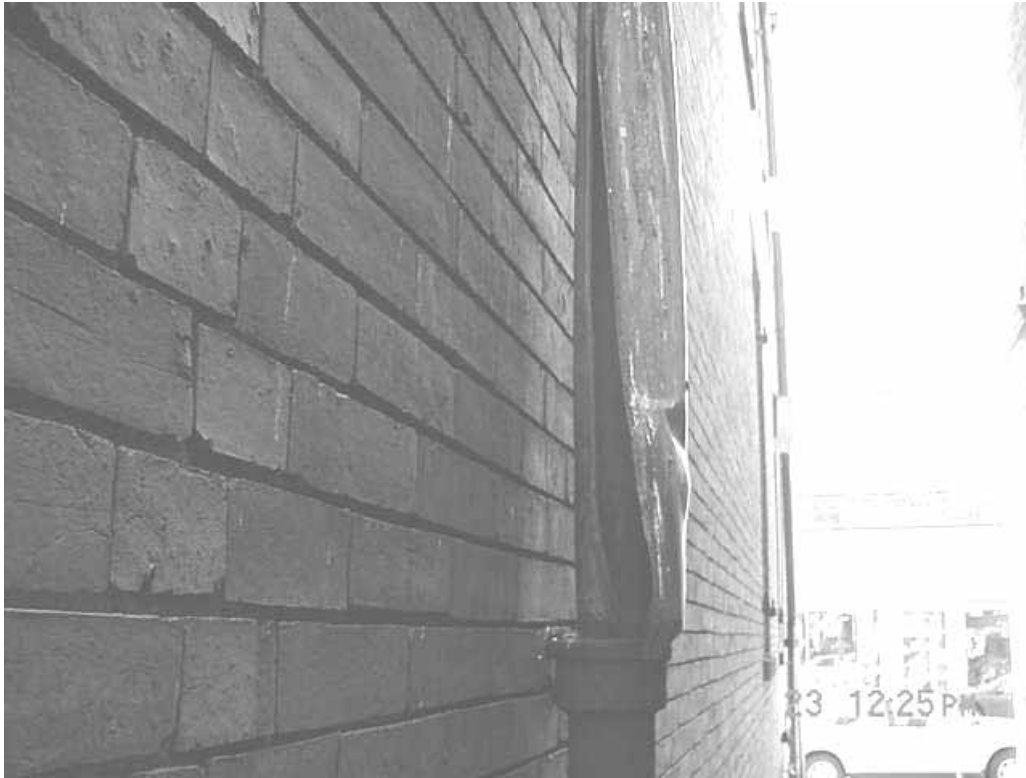
**Picture 6**

The gutter/downspout system on the east exterior wall was damaged and sections of the exterior wall were saturated with moisture (Picture 6). A section of the gutter/downspout system on the west corner of the building was missing (Picture 7). Some areas of exterior brick had missing/damaged mortar (Picture 8). Excessive exposure of exterior brickwork to water can result in structural damage. During winter weather, the freezing and thawing of moisture in bricks can accelerate the deterioration of brickwork. Over time, these conditions can undermine the integrity of the building envelope and provide a means for water entry into the building through capillary action through foundation concrete and masonry (Lstiburek & Brennan, 2001).

**Damaged (Split-Open) Downspout on East Side of Building**

1. Open windows to temper room temperature and provide fresh air. As discussed, this building was designed to use windows (in combination with radiators) to provide fresh air and heat. Care should be taken to ensure windows are properly closed at night and weekends to avoid the freezing of pipes and potential flooding.
2. Consider supplementing fresh air by operating window-mounted air conditioners in the "fan only" "fresh air" mode, which introduces outside air by mechanical means.
3. Consider consulting with an architect, masonry firm or general contractor regarding the integrity of the building envelope, primarily concerning water penetration through exterior walls. Ensure all leaks are repaired. Once leaks are repaired, repair water-damaged plaster/paint and examine the feasibility of repointing brickwork.
4. Repair/replace missing/damaged sections of gutter/downspout system.

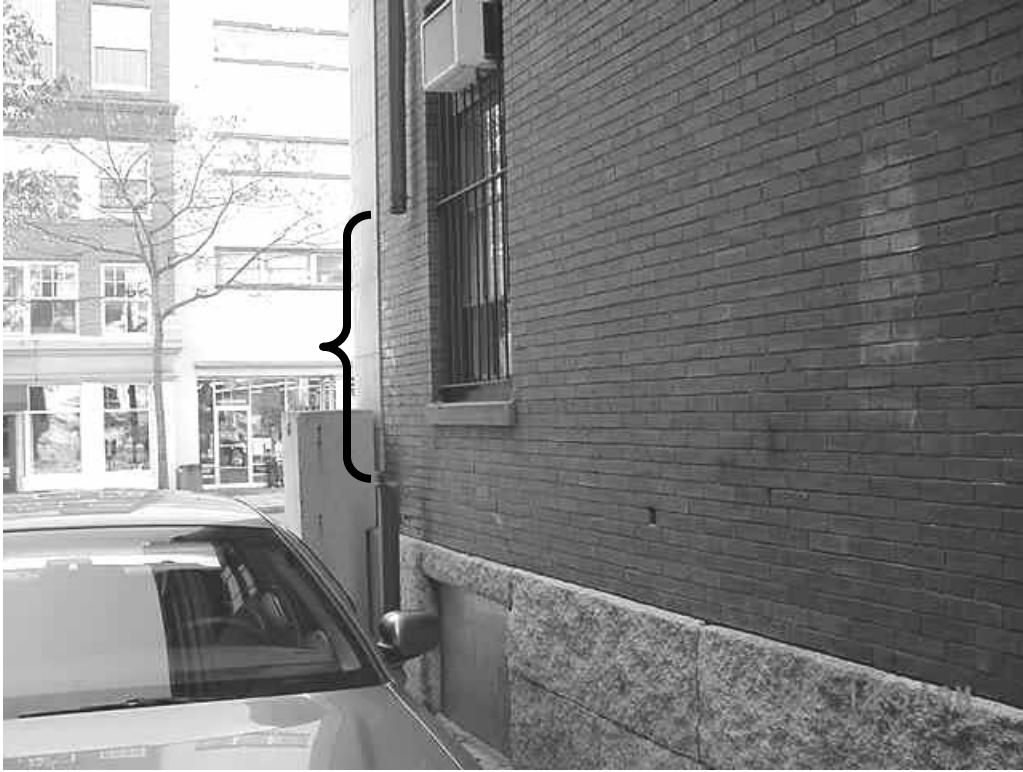
**Picture 7**

**Missing Section of Downspout on West Corner of Building**

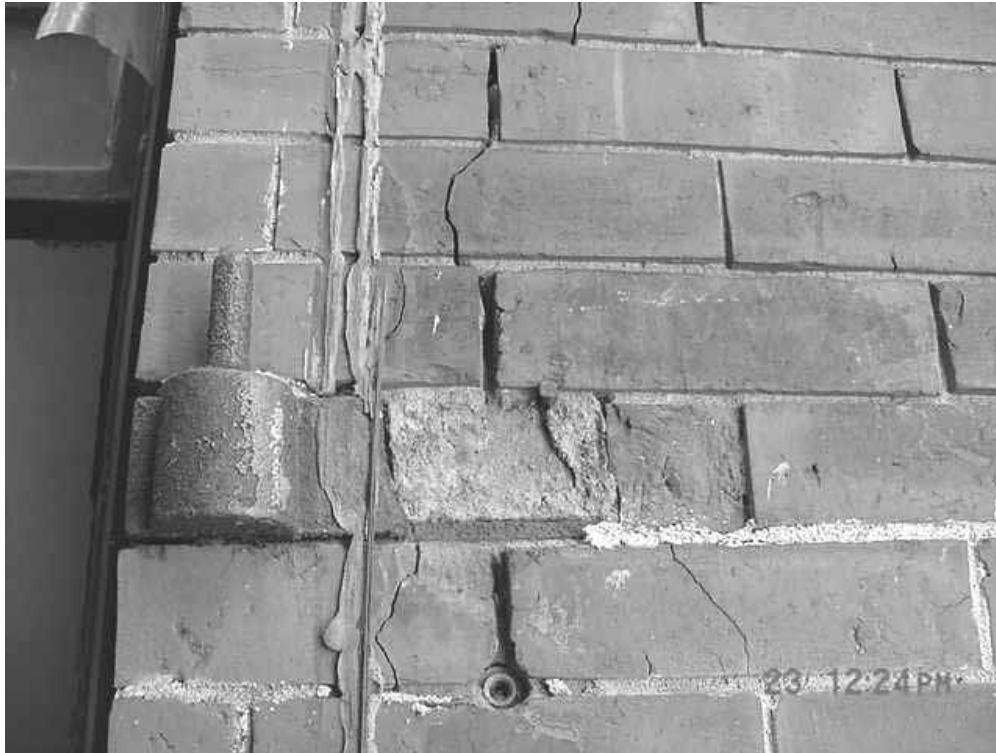
**Picture 8**

**Missing/Damaged Mortar around Exterior Brick**

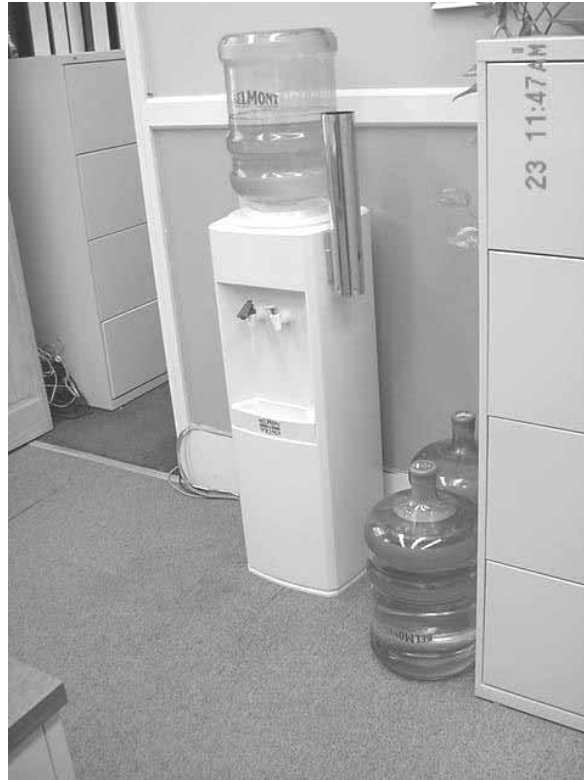
**Picture 9**

A number of areas had water coolers installed over carpeting (Picture 9). Water spillage or overflow of cooler catch basins can result in the wetting of the carpet. In addition, some of the coolers had residue/build-up in the reservoirs. These reservoirs are designed to catch excess water during operation and should be emptied/cleaned regularly to prevent microbial and/or bacterial growth.

**Water Cooler on Carpeting**

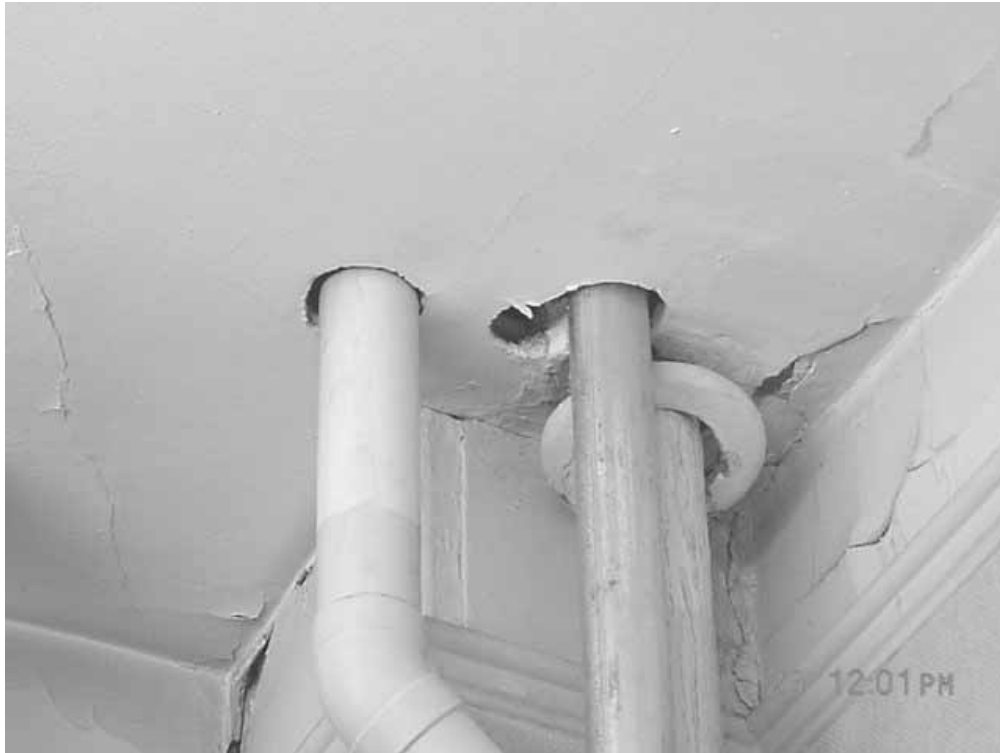
**Picture 10**

Finally, several areas around the building had open utility holes for pipes, cables, etc. (Picture 10). Open utility holes can provide a means for odors and/or particulates to migrate between rooms and floors.

**Open Utility Holes around Pipes**
